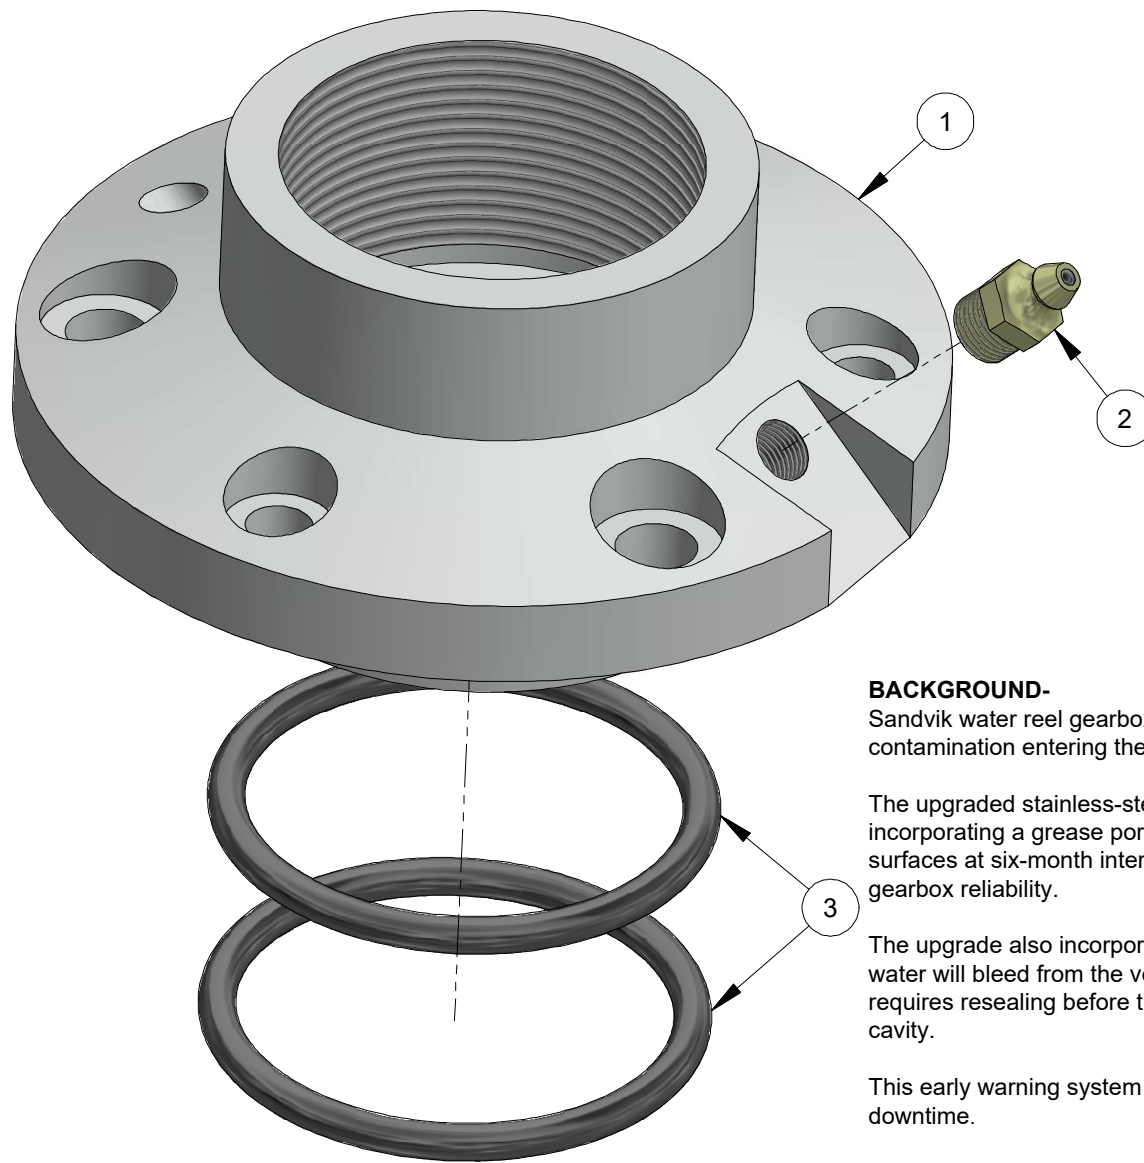
Sandvik water reel gearboxes commonly experience failure due to water contamination entering the gearbox cavity when the flange seal leaks.

The upgrade also incorporates a vent port. Should the primary seal begin to fail, water will bleed from the vent, providing a clear visual indication that the unit requires resealing before the secondary seal fails and water enters the gearbox cavity.

The upgraded stainless-steel flange has been designed to address this issue by incorporating a grease port, allowing grease to be applied between the sealing surfaces at six-month intervals. This significantly extends seal life and improves gearbox reliability.
